Five-Year Review Report
Second Five-Year Review Report
for
Master Disposal Landfill Site
City of Brookfield
Waukesha County, Wisconsin

September 2005

**PHOTOGRAPH LOG OF FIVE-YEAR REVIEW
SITE INSPECTION
APRIL 19, 2005**

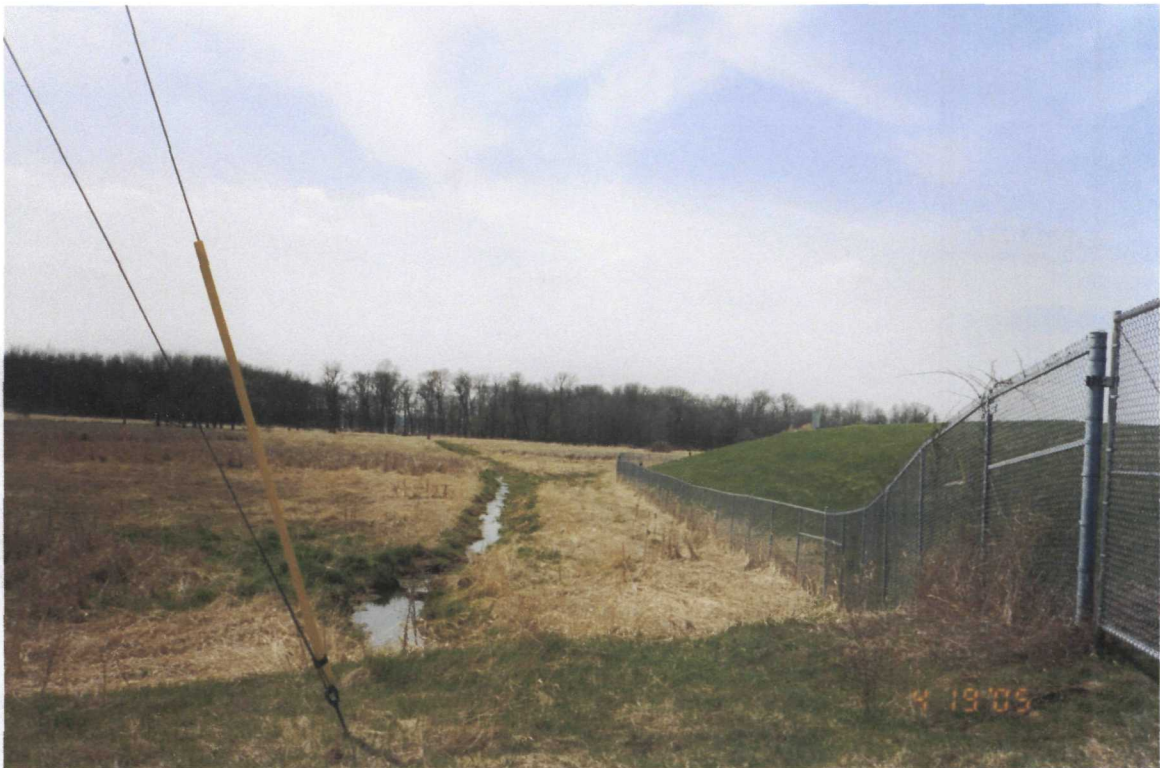
Photo 1: From southeast corner, just outside the front gate of the Master Disposal Service Landfill Site looking westward along southern property edge fence line. The main drainage channel to the Fox River is visible.

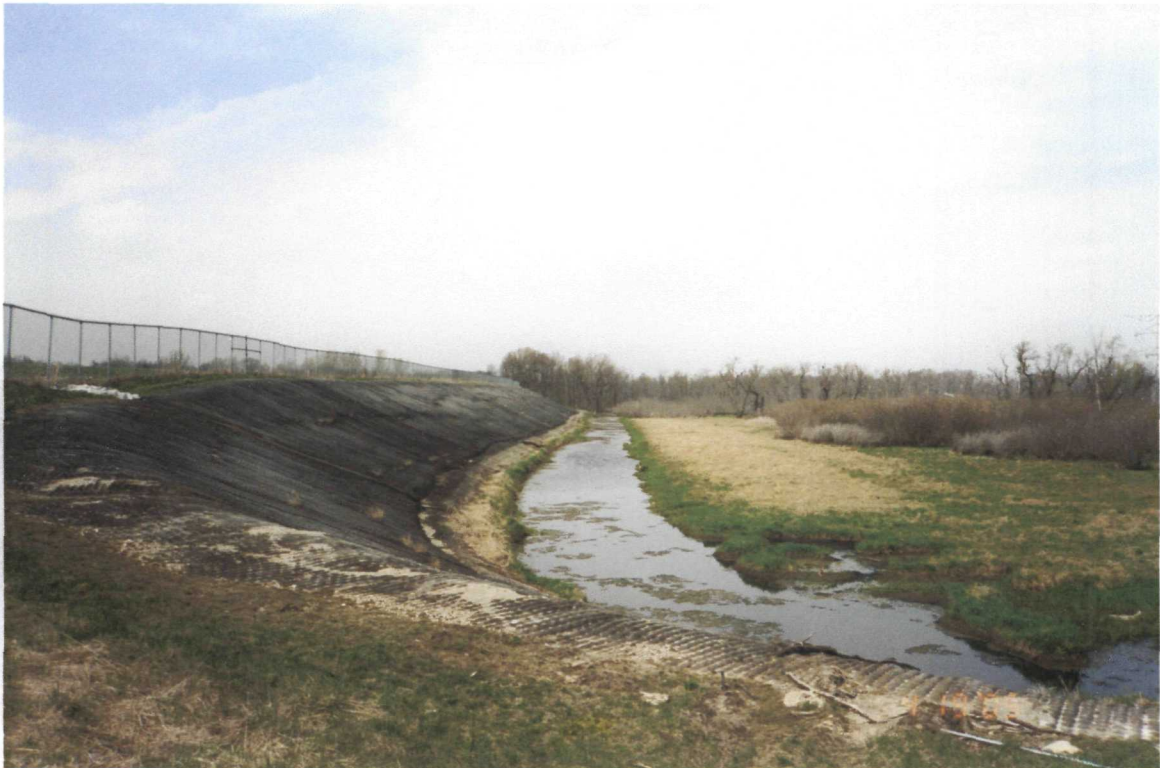
Photo 2: From southeast corner of Site looking north along and outside the eastern property fence line. The 60-mil HDPE geomembrane overlain with concrete mat is visible outside the fence. This is used to maintain the steep slope and reduce disturbance to the wetland on the right.

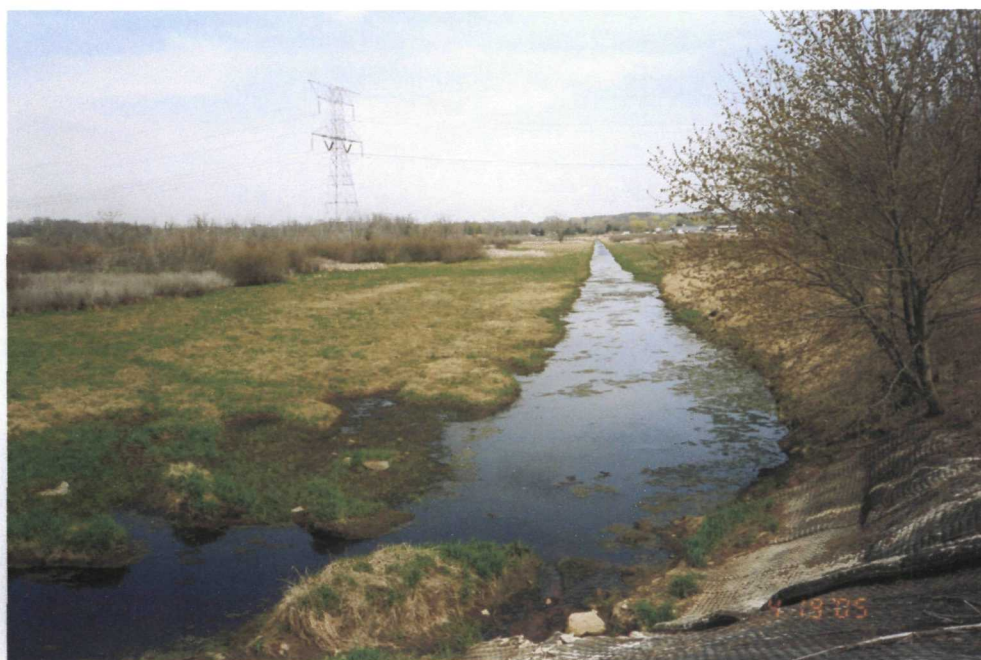
Photo 3: From southeast corner of landfill at fence looking eastward onto main drainage channel. Geomembrane and concrete matting are visible in the foreground. Wetlands with bird rookeries continue to the left (north) off the photo frame.

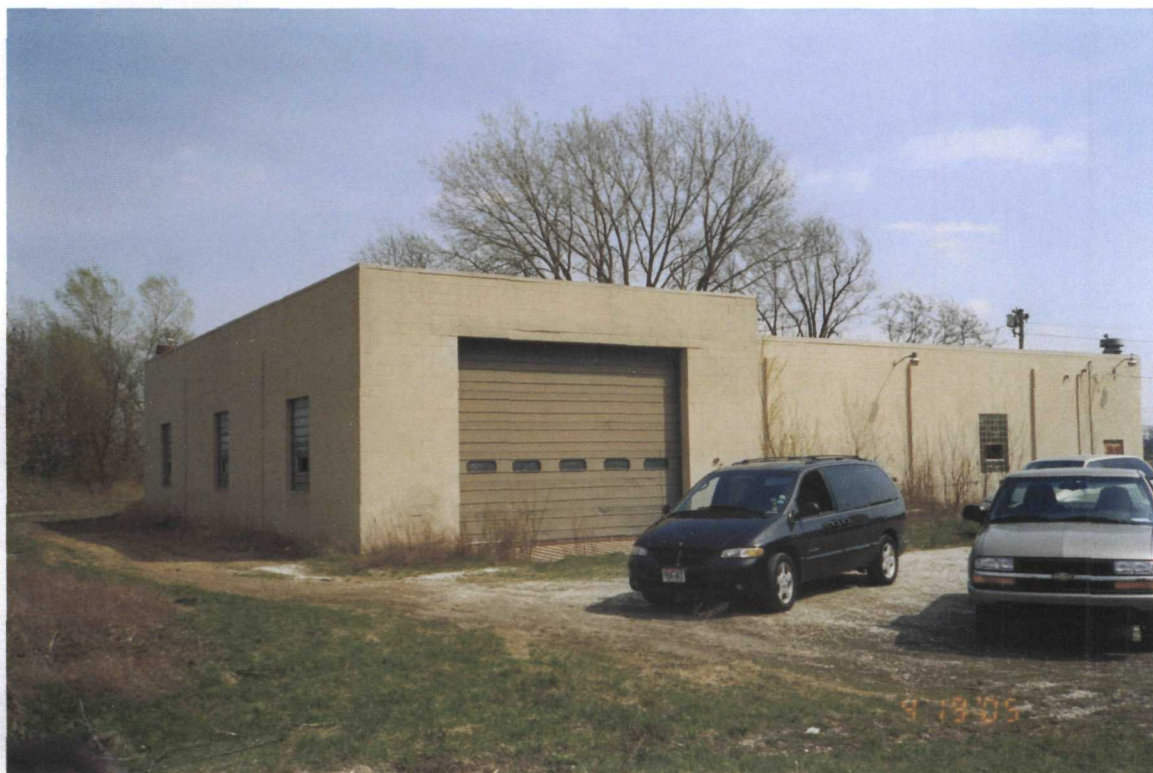
Photo 4: From southeast corner of property looking at garage building located within the small area south of the main drainage channel. The building appeared to store old automotive equipment but is not used regularly.

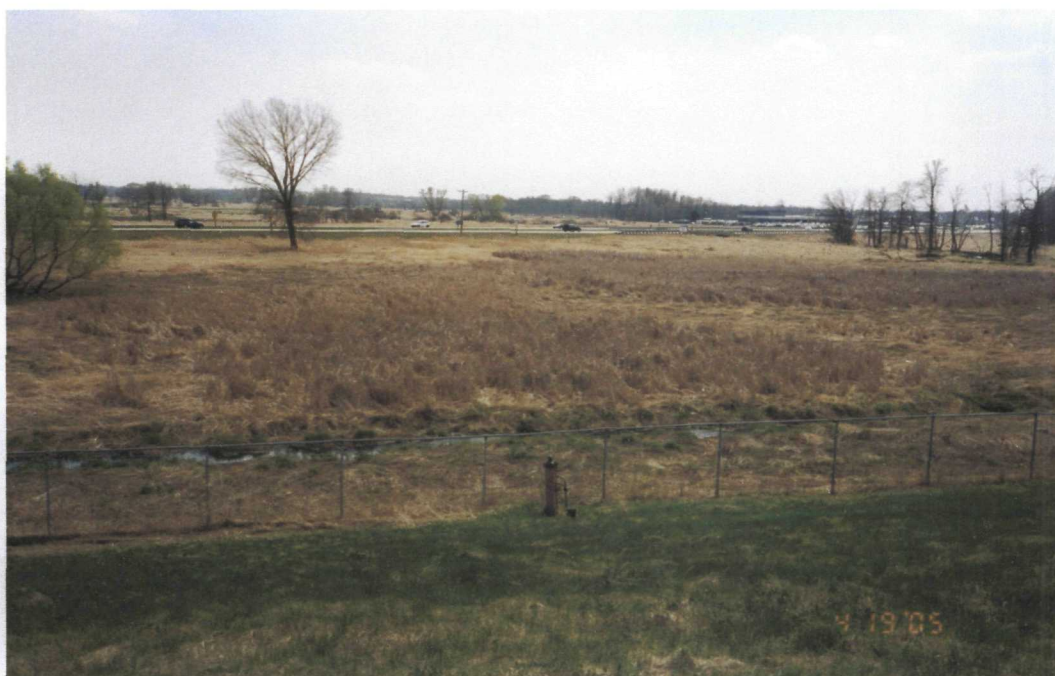
Photo 5: Looking southward to Extraction Well 1 (EW-1) with West Capitol Drive in the background. The main drainage channel is visible just beyond the fence line.

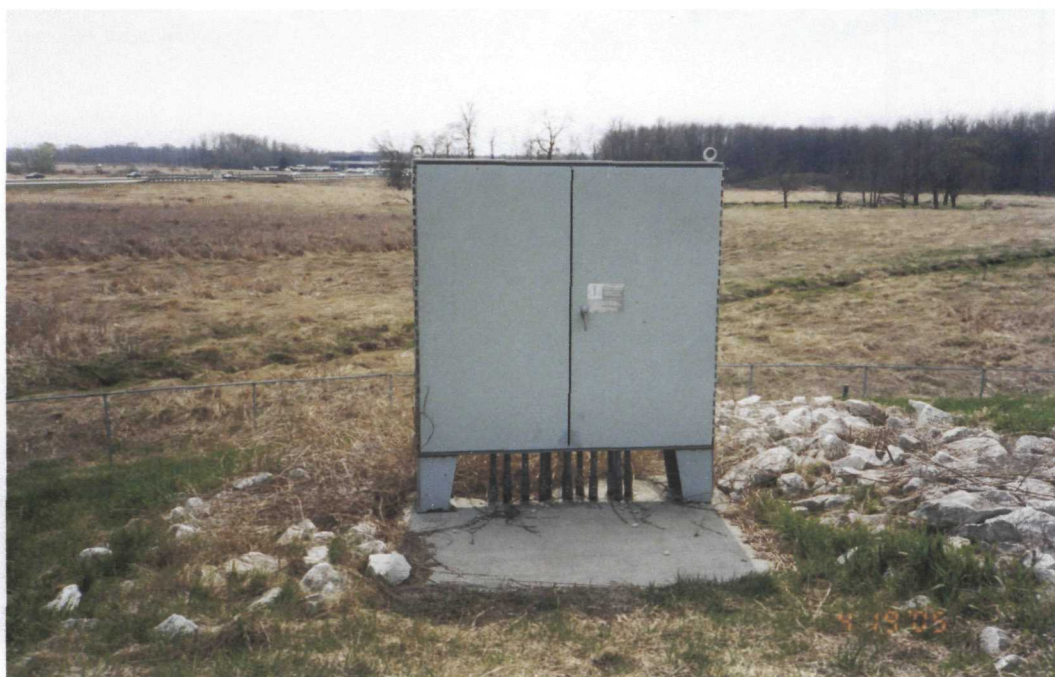
Photo 6: Looking southwest from the southeastern part of the cap. The first of three electrical panels which operate the transducers for groups of 3 to 4 of the extraction wells. West Capitol Drive is in the far background.

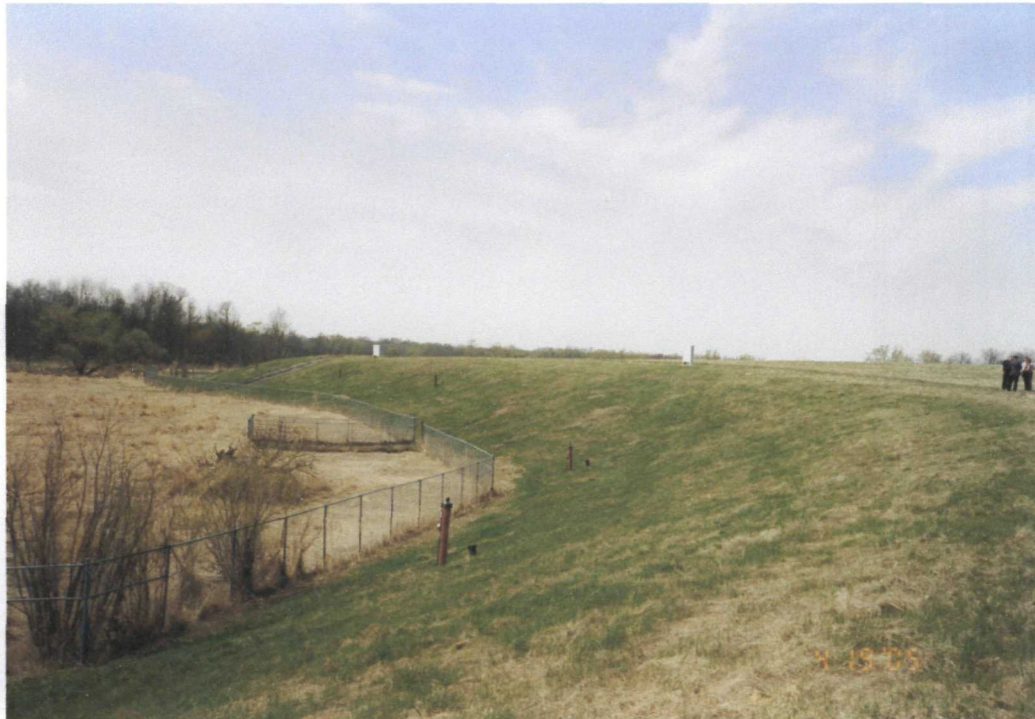
Photo 7: Looking westward along the southern fence line of the landfill. The extraction wells and piezometers are visible in the mid-ground and background along the fence line. Electrical panels No. 2 and 3 are visible along the crest of the landfill.

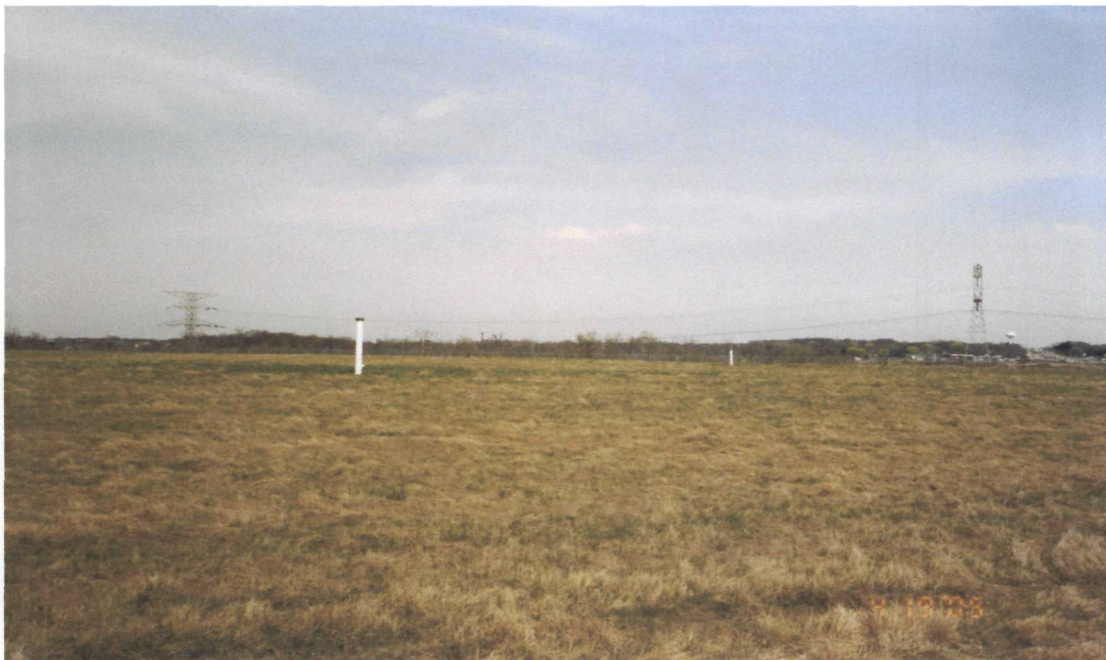
Photo 8: Looking southeast, two landfill passive gas vents (tall, white casings) are visible in the mid-ground and background of the photo.

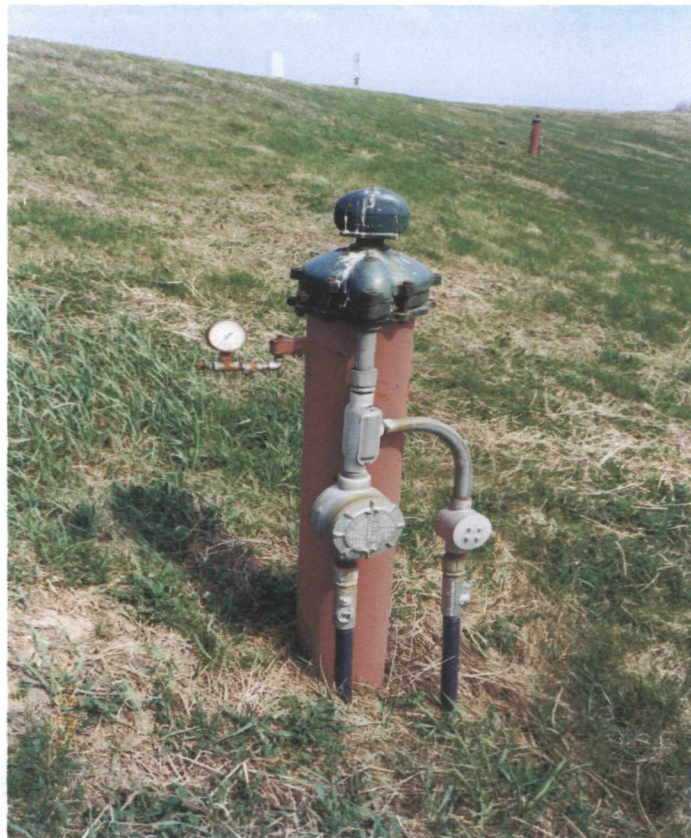
Photo 9: Close-up of EW-8. EW-7 is visible near the upper right-hand corner of the photo. Electrical panel No.2 is visible as a white box along the top contour of the landfill.

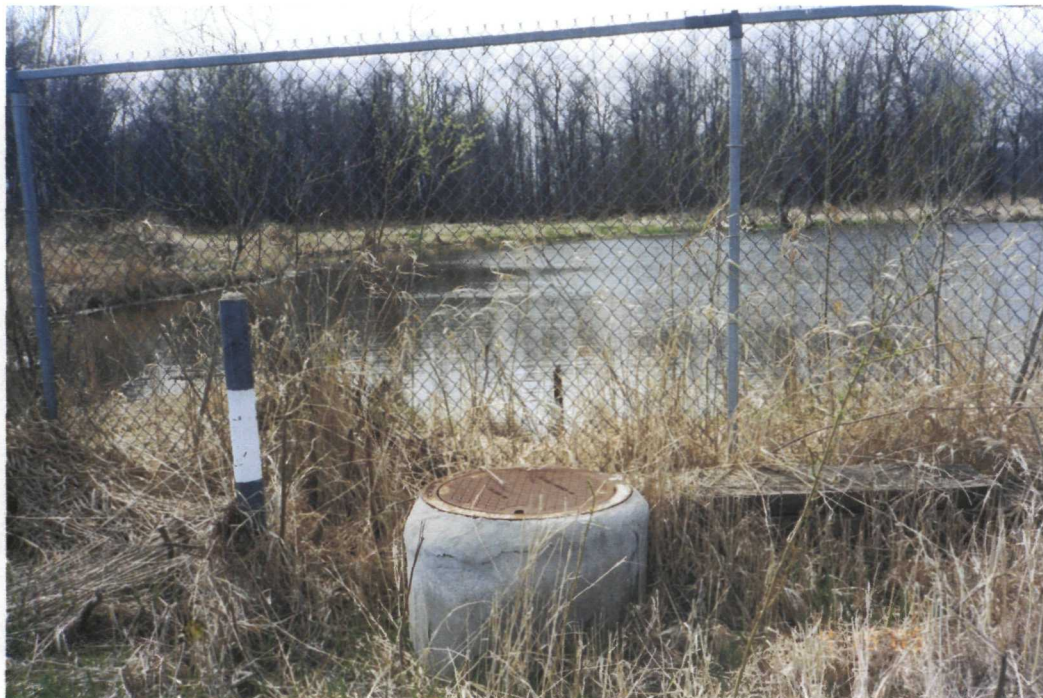
Photo 10: Composite extraction well discharge area where sampling occurs prior to discharging groundwater to the pond visible beyond the fence.

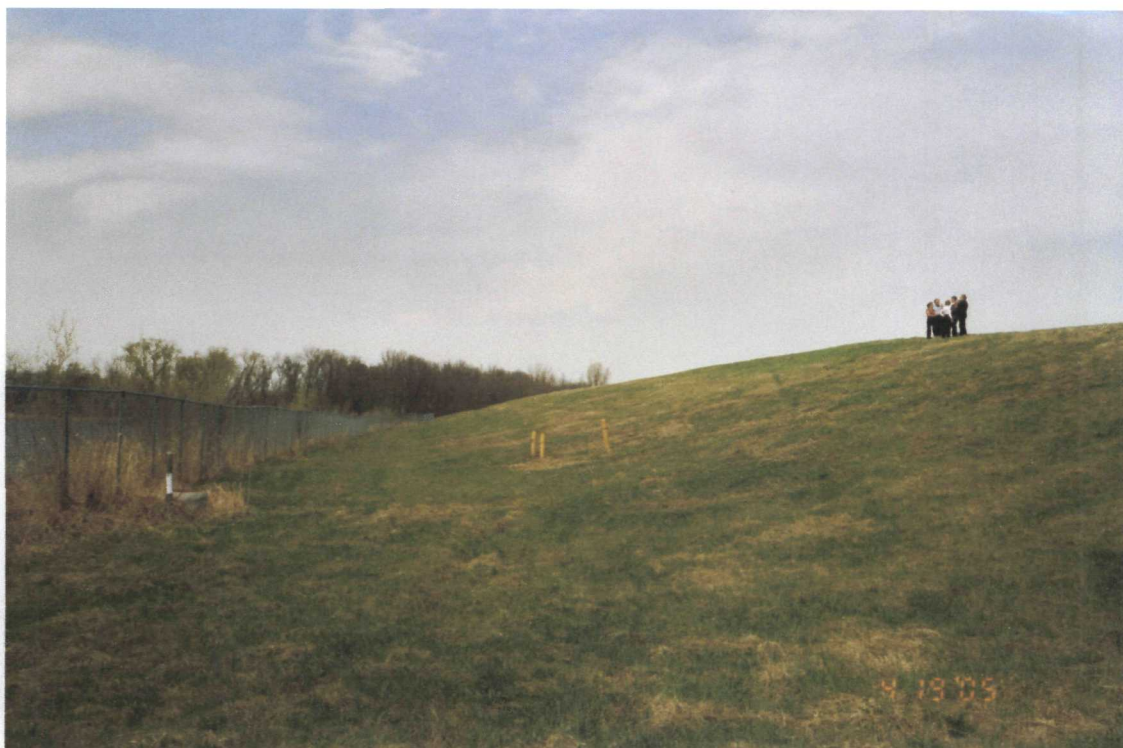
Photo 11: Looking northward, the western border of the landfill shows the slope. The pond is just left of the visible fence line.

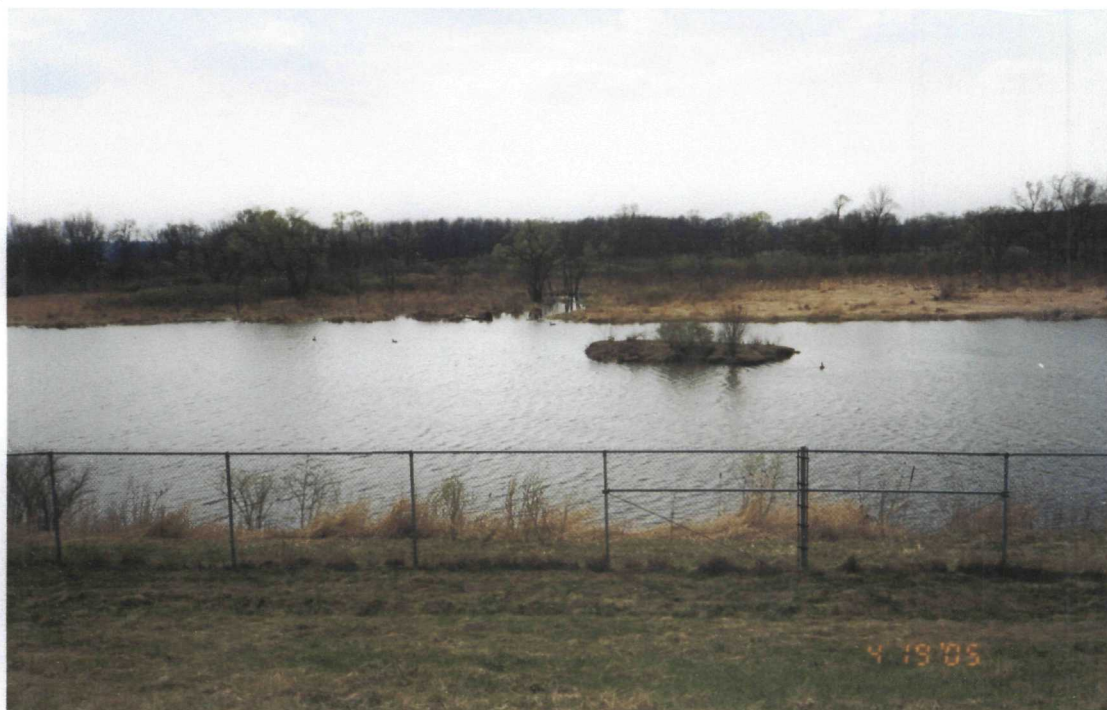
Photo 12: From western landfill slope looking toward western fence line and pond. The discharge point from the pond to the wetlands and into the Fox River is visible just in back of the left edge of the island. One of the gates in the fence line accessing the pond is visible.

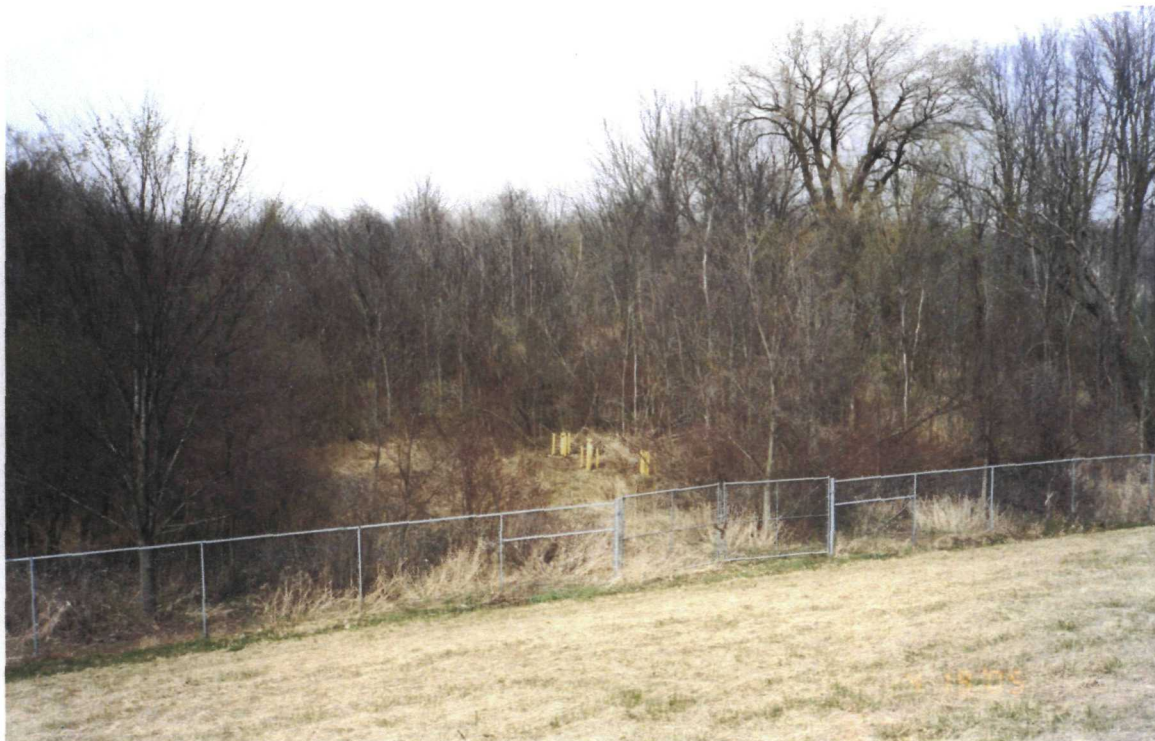
Photo 13: Looking at the northeast corner of the landfill toward the upgradient background monitoring wells (B-47, B-48, and B-53) indicated by the yellow stakes in the middle of the photo. One of the gates accessing these wells is visible.

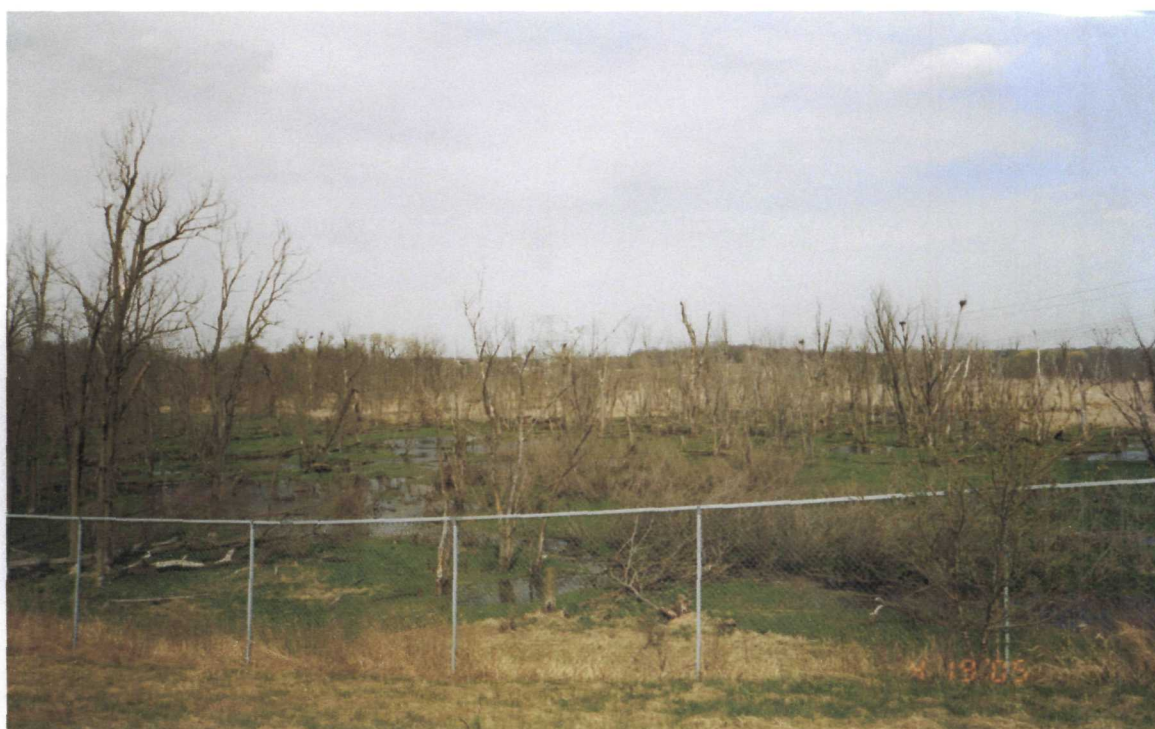
Photo 14: Wetland outside of the northeastern fence line of the landfill. Bird rookeries are visible in the treetops on the right side of the photo background.

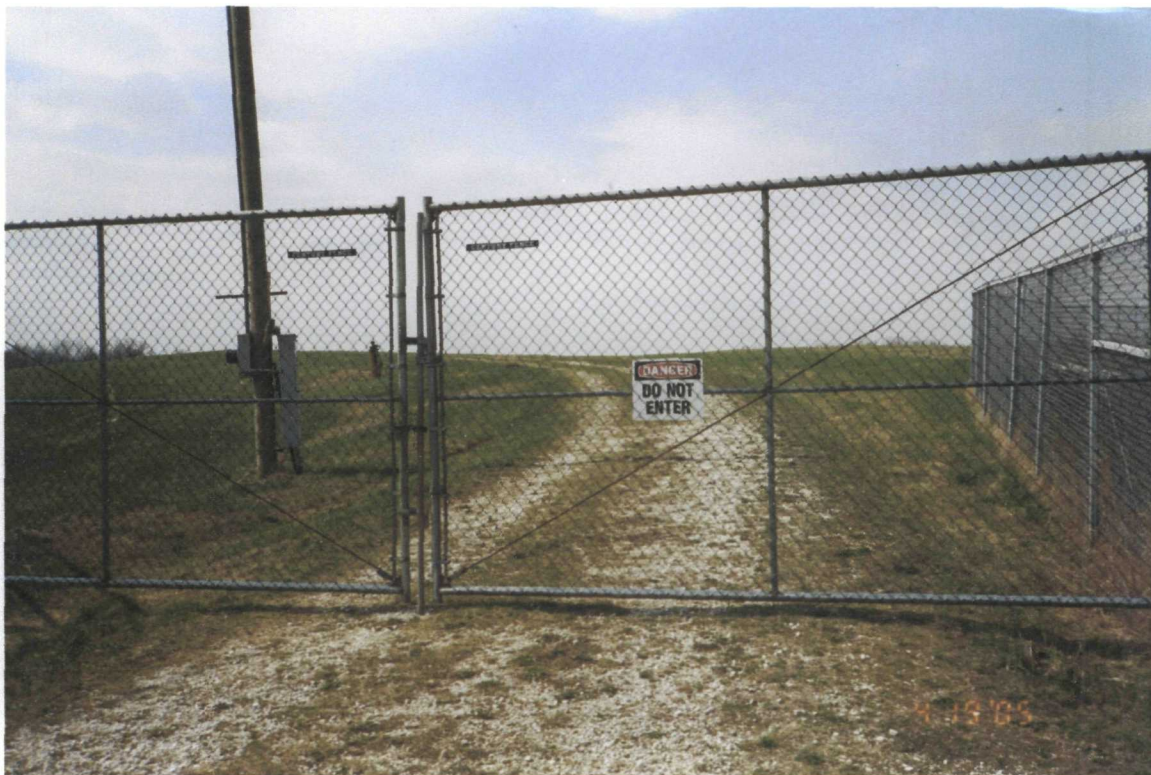
Photo 15: Front main gate to the landfill property on the southeast side of the landfill. The gate is accessed via a gravel road off West Capitol Drive. The only posted sign on the fence line is visible on the gate.

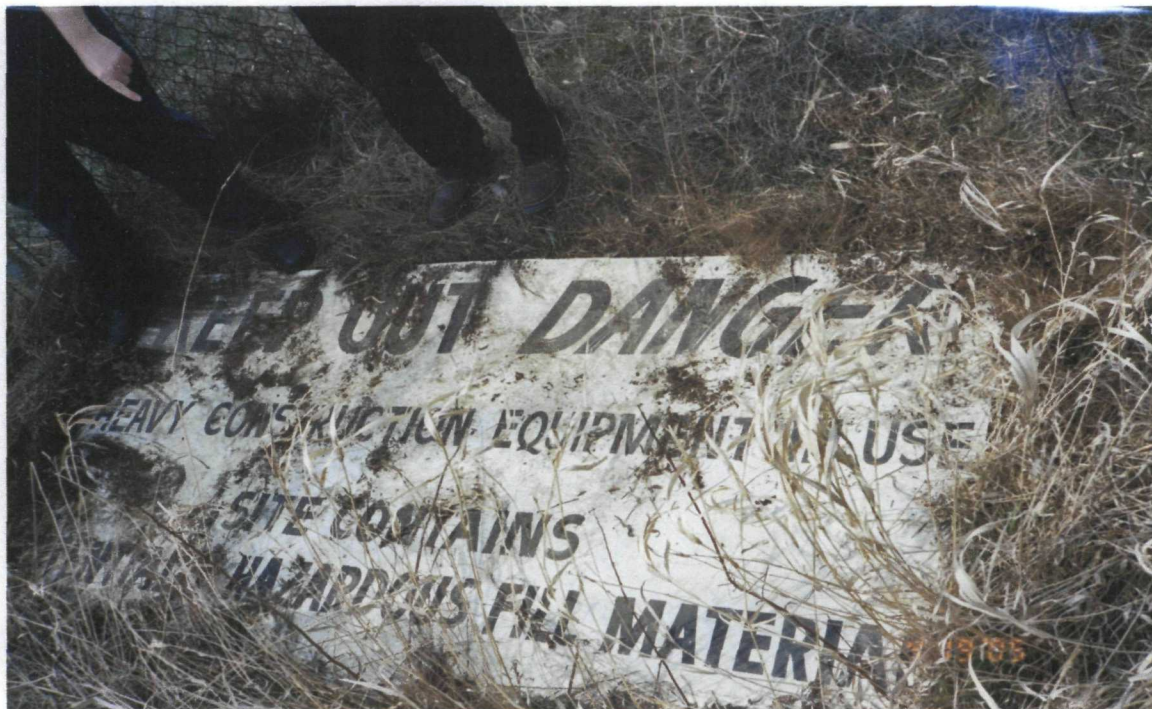
Photo 16: Sign uncovered near the southern fence in the garage area of the property. The sign reads: "Keep Out Danger, Heavy Construction Equipment in Use, Site Contains Potentially Hazardous Fill Material" and was apparently used during the remedial action.
